Structural Collapse: The Hidden Dangers of Residential Fires

By James M. Dalton, Robert G. Backstrom, and Steve Kerber

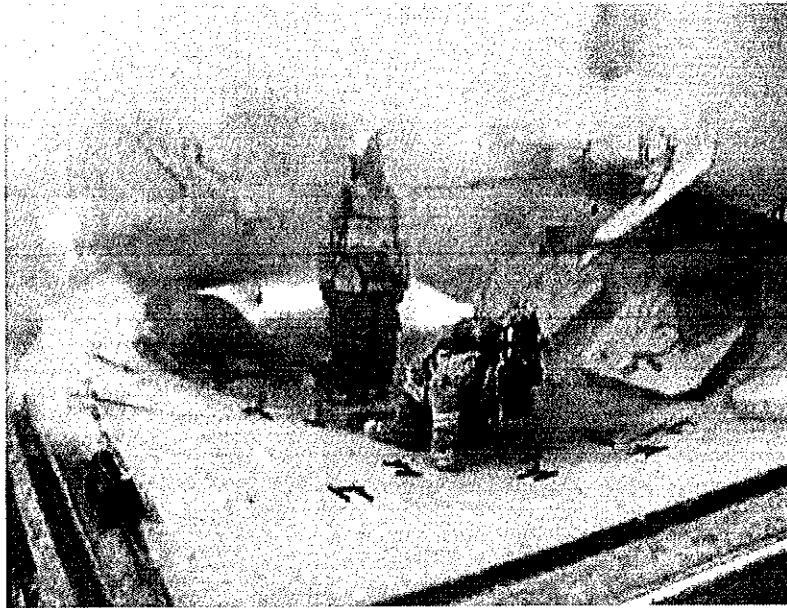
(5) A modern lightweight 12-inch wood I-joist floor—without ceiling. Collapse Time = 06:03. (5) The excessive floor deflections at the time of failure. (6) The condition of one of the surviving engineered I-joists after extinguishment.

A review of the ASTM E119 and ISO 834:1 failure times as they apply to the unprotected (without ceiling) engineered wooden I-joint assembly clearly illustrates that the floor had become significantly damaged and lost its ability to carry load far before the actual total collapse time. If the ISO standard was applied to the unprotected engineered wooden I-joint assembly, the accepted failure time would change from 06:03 (acceptance criteria time per the ASTM E119 standard) to 04:00 (load-bearing capacity per the ISO 834:1 standard). For the fire service, this means that a complete collapse of this floor would have been seen at 06:03 but that the floor would have been severely compromised and potentially unsafe to operate on at 04:00. Be aware that although these testing methods provide documented research failure times, they also illustrate that the floors have become dangerous far before the actual documented collapse times. This trend was consistent throughout the engineered lumber assemblies tested within this study. These failures in real-life incidents may also be accelerated by larger fire loads and variations in field conditions.
